6th International Congress on
*“Science and Technology for the Safeguard of
Cultural Heritage in the Mediterranean Basin”*
PROCEEDINGS

SILICA THIN FILM SYNTHETIZED BY SOL-GEL PROCESS FOR THE PROTECTION OF OUTDOOR ARTISTIC CERAMIC IN ARCHITECTURE

Renzo Bertoncetto^{1*}, Claudia Bortolussi², Michele Cecchin², Daniela Lattanzi³

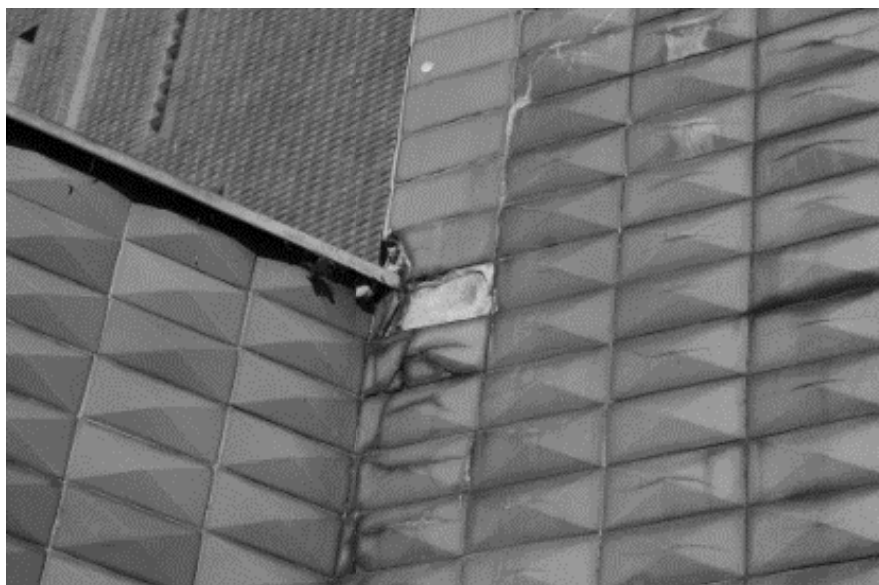
Figure 2. The degradation processes affect especially the cusps of the tiles. The cracking of the glaze evolves in the fracture of the ceramic body with loss of tiles. It is possible to recognize the efflorescences along the path of flow of water.

Even if the surfaces appeared in general smooth, the ESEM images show an irregular surface of the tile, due to efflorescence, deposits and alveoli. At a microscopic scale, the glaze is affected by micro cracking, pitting corrosion and scattered alveoli. The phenomena are much more diffuse in tiles from the southern façade, which is exposed to direct solar irradiation and thus to a temperature range larger than the others. The degradation occurs especially on the cusps. The discontinuities of the glaze weaken the whole material thus being more subjected to degradation with respect to the intact material. The micro cracks may evolve in fractures involving not only the glaze but also the ceramic body (Fig.2). Chemical elements not belonging to the chemical composition of the ceramic were transported by polluted meteoric water which flows preferentially along the discontinuities. In particular, Cu and Fe are attributed to the drainpipes and to the metallic roofing, while P is associated to organic residues.

The pitting corrosion was observed in the original and in the new material, supporting the hypothesis that the phenomenon is not related to weathering processes but it is an intrinsic feature of the ceramic. The shape and the distribution of the alveoli which are characterized by a central hole are related to the expulsion of air bubbles during the firing process.
